# Alternate Nozzle Ablative Materials Program

N. A. Kimmel

September 1, 1984

Prepared for  
**NASA Marshall Space Flight Center**  
through an agreement with  
**National Aeronautics and Space Administration**  
by  
**Jet Propulsion Laboratory**  
California Institute of Technology  
Pasadena, California

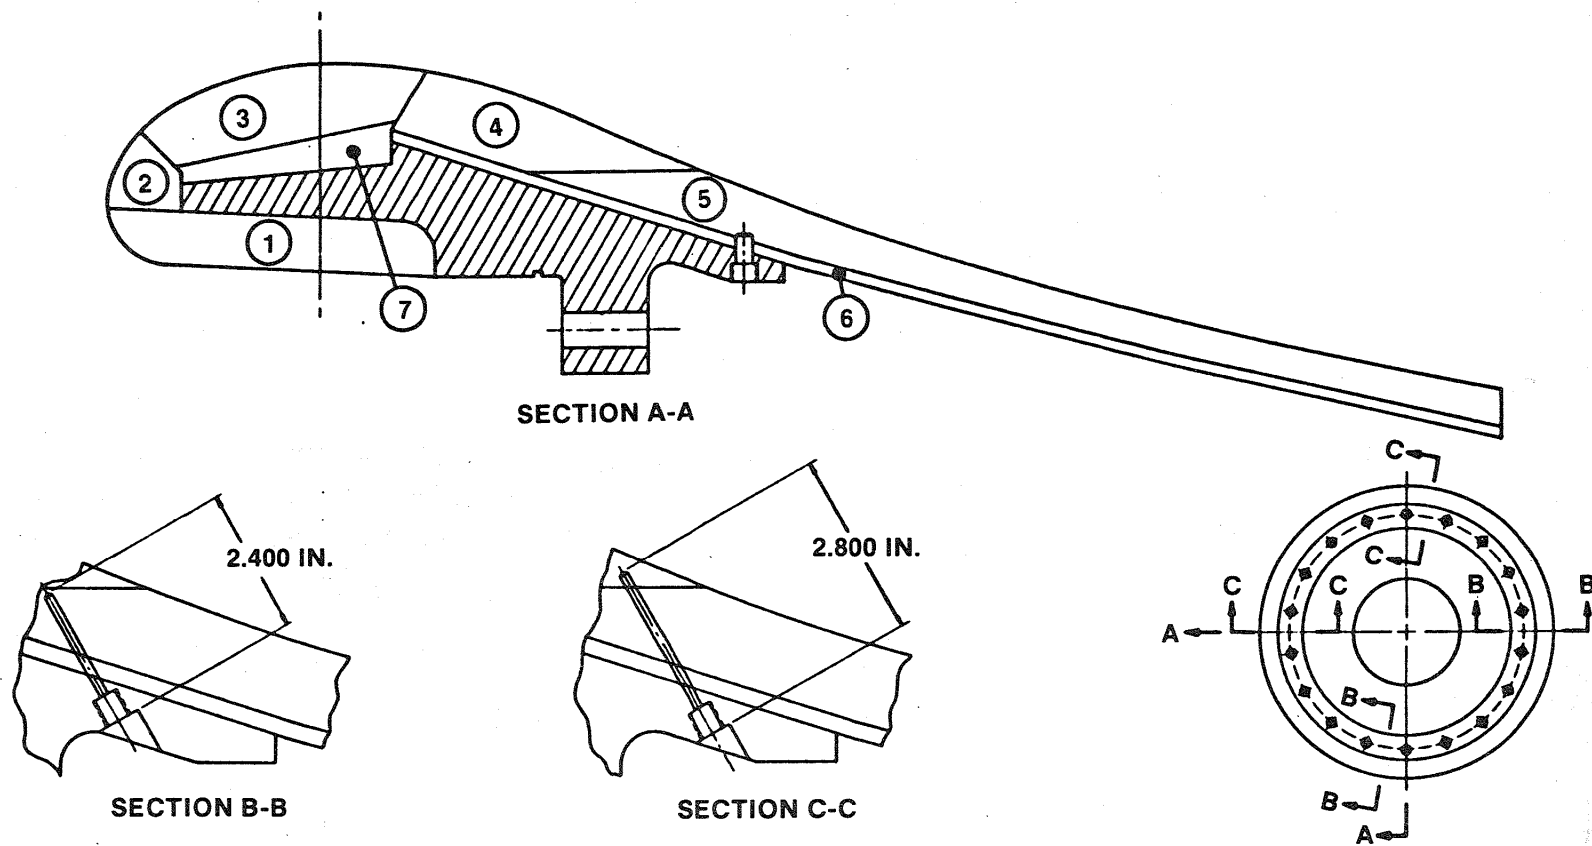
Figure 2. N-1 Nozzle Materials and Thermocouple Locations

| PART | 1 | 2 | 3 | 4 | 5 | 6 | 7 |
| MATERIAL | FM5055 | FM5055 | FM5055 | FM5055 | FM5055 | MXB6020 | MXB6020 |

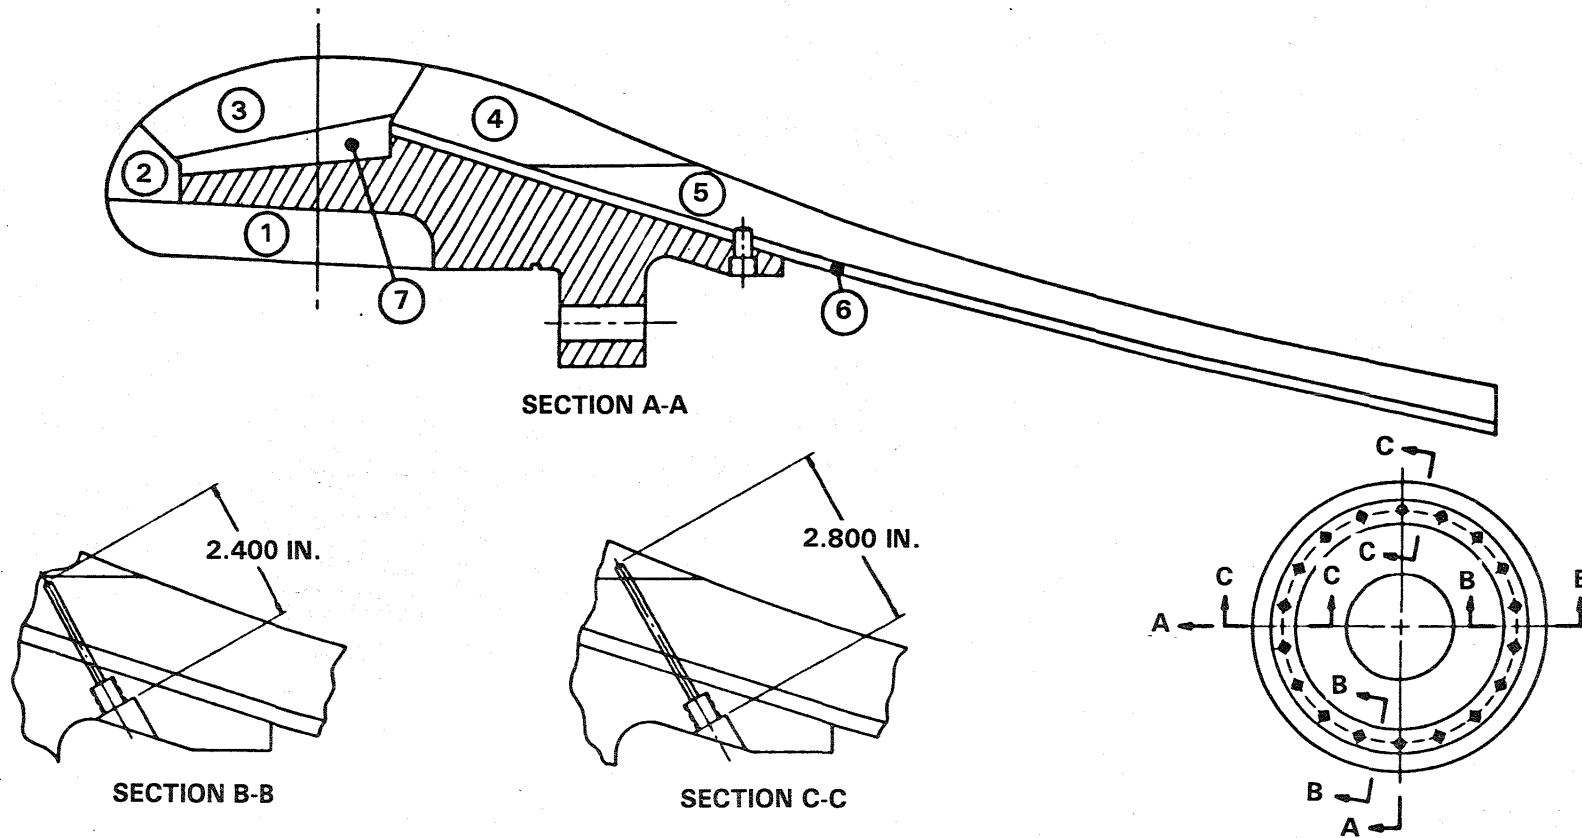
| PART | 1 | 2 | 3 | 4 | 5 | 6 | 7 |
| MATERIAL | MX4961A | FM5879 | K411 | MX4961 | MX4961B | FM5755 | MXR520 |

The nozzle assembly that was employed for test number 2 (N-2) is shown in Fig. 3. The composite materials used in the manufacture of the seven components (parts) are as depicted in Fig. 3 and are described in Section III-B.

Four probe-type thermocouples (shielded and grounded construction), to the specifications shown in Table 1, were installed on the test N-2 nozzle assembly at the locations depicted in Fig. 3: two at Section B-B and two at Section C-C.

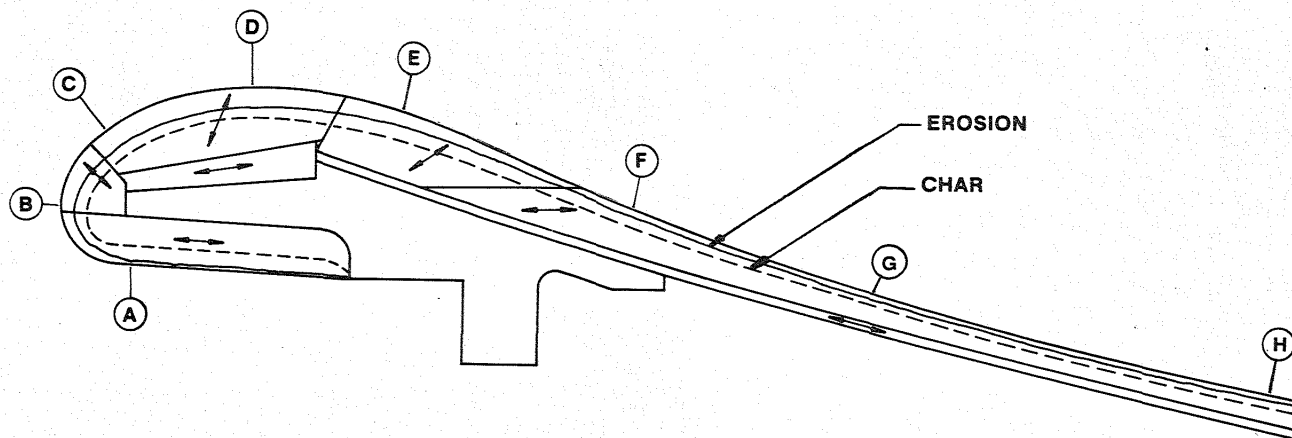
Figure 4. N-1 Nozzle Predicted Erosion and Char Thickness and Backside Temperatures

Figure 4 presents predicted erosion and material affected depth at selected locations. The maximum predicted backside temperature is 140°F and occurs in the aft exit cone region.

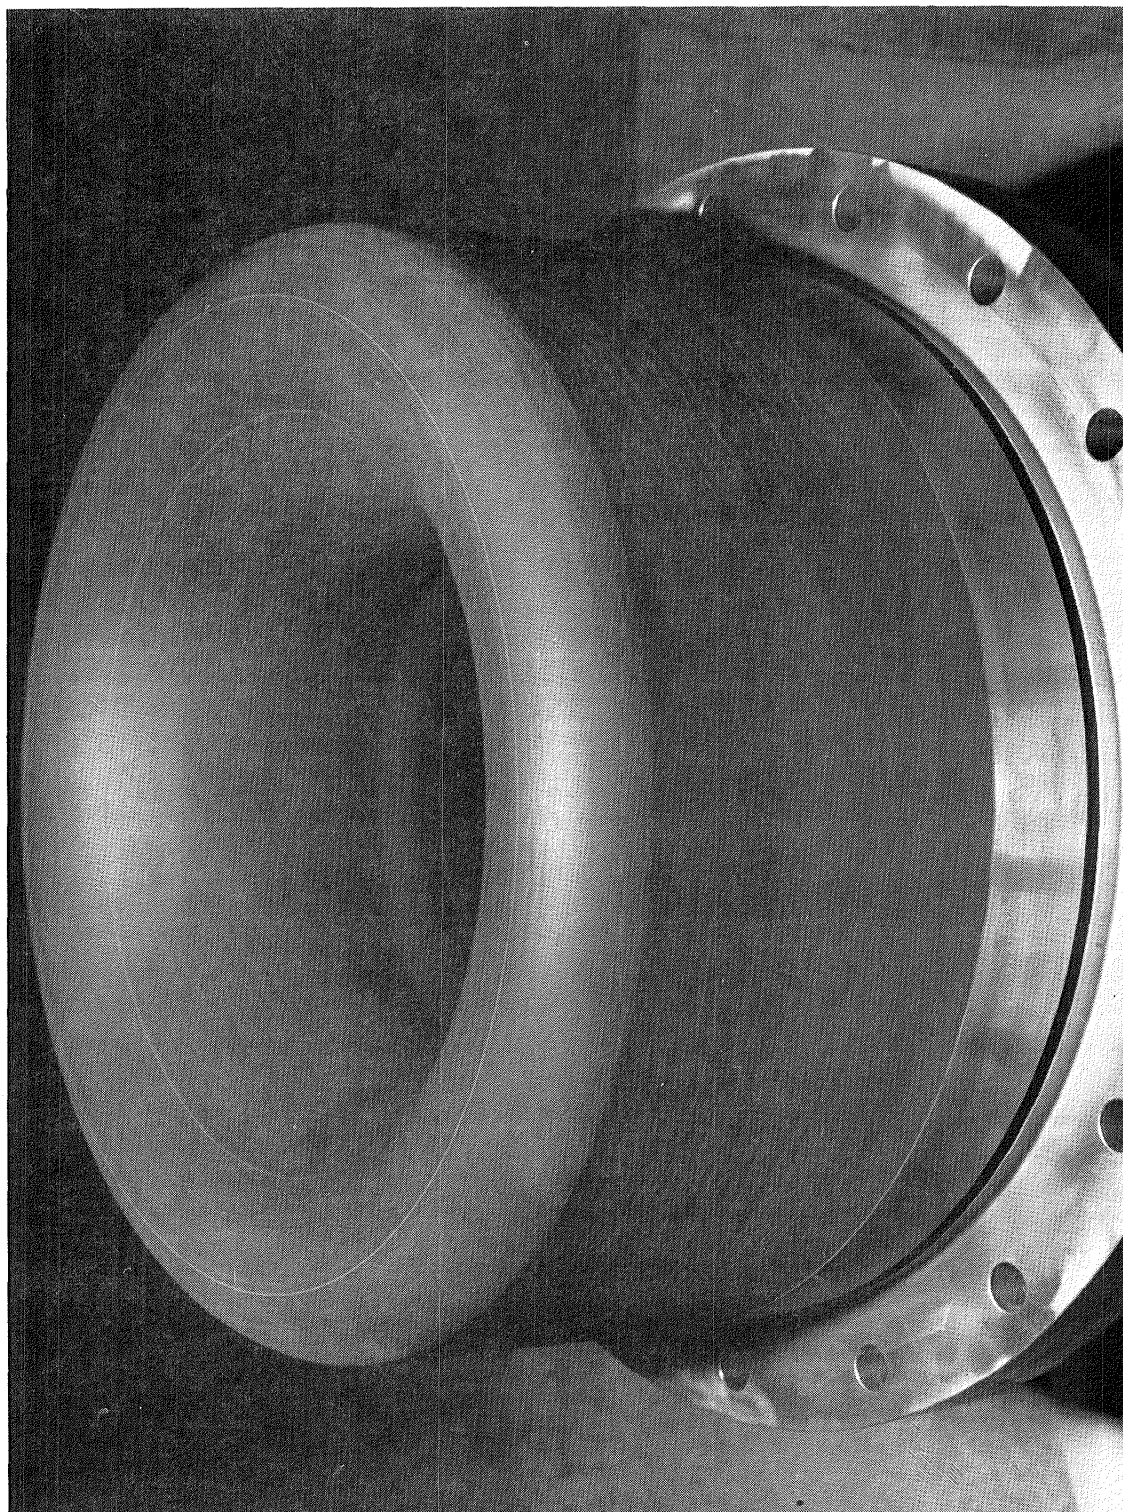
Figure 5. N-1 Nozzle Nose and Throat Section

The prefire throat diameter was 9.499 in. and finished nozzle weight was 536.5 lb. Figures 5 and 6 present prefire photographs of the nozzle.

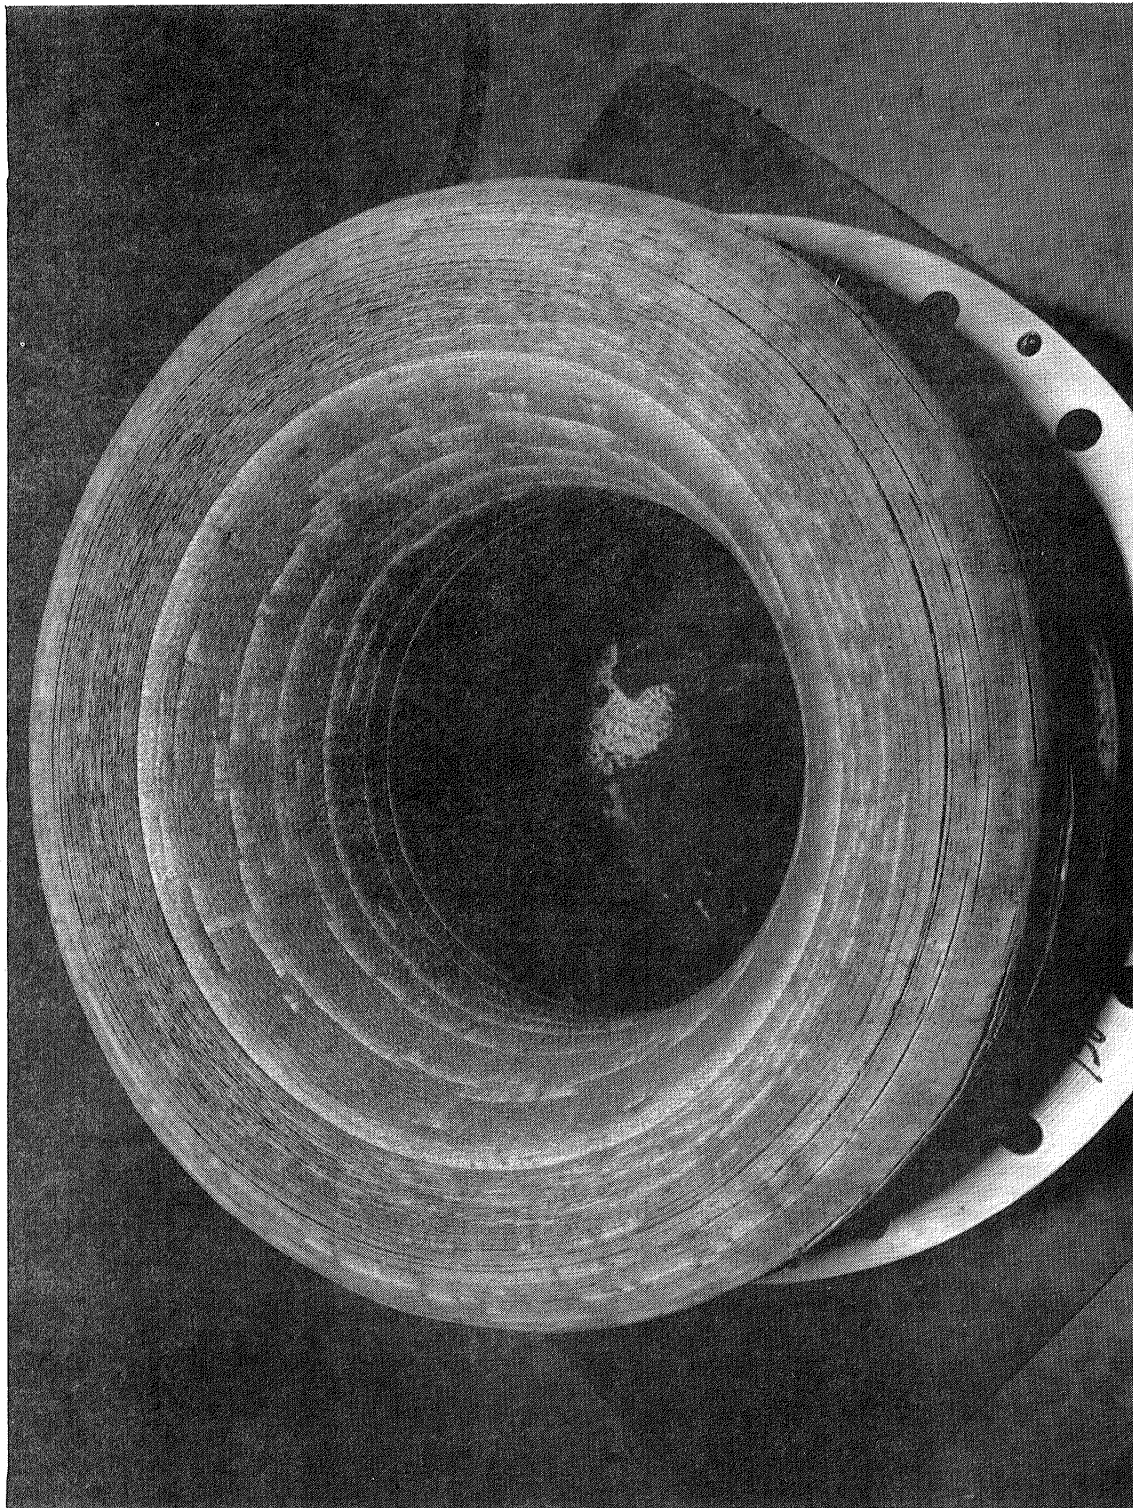
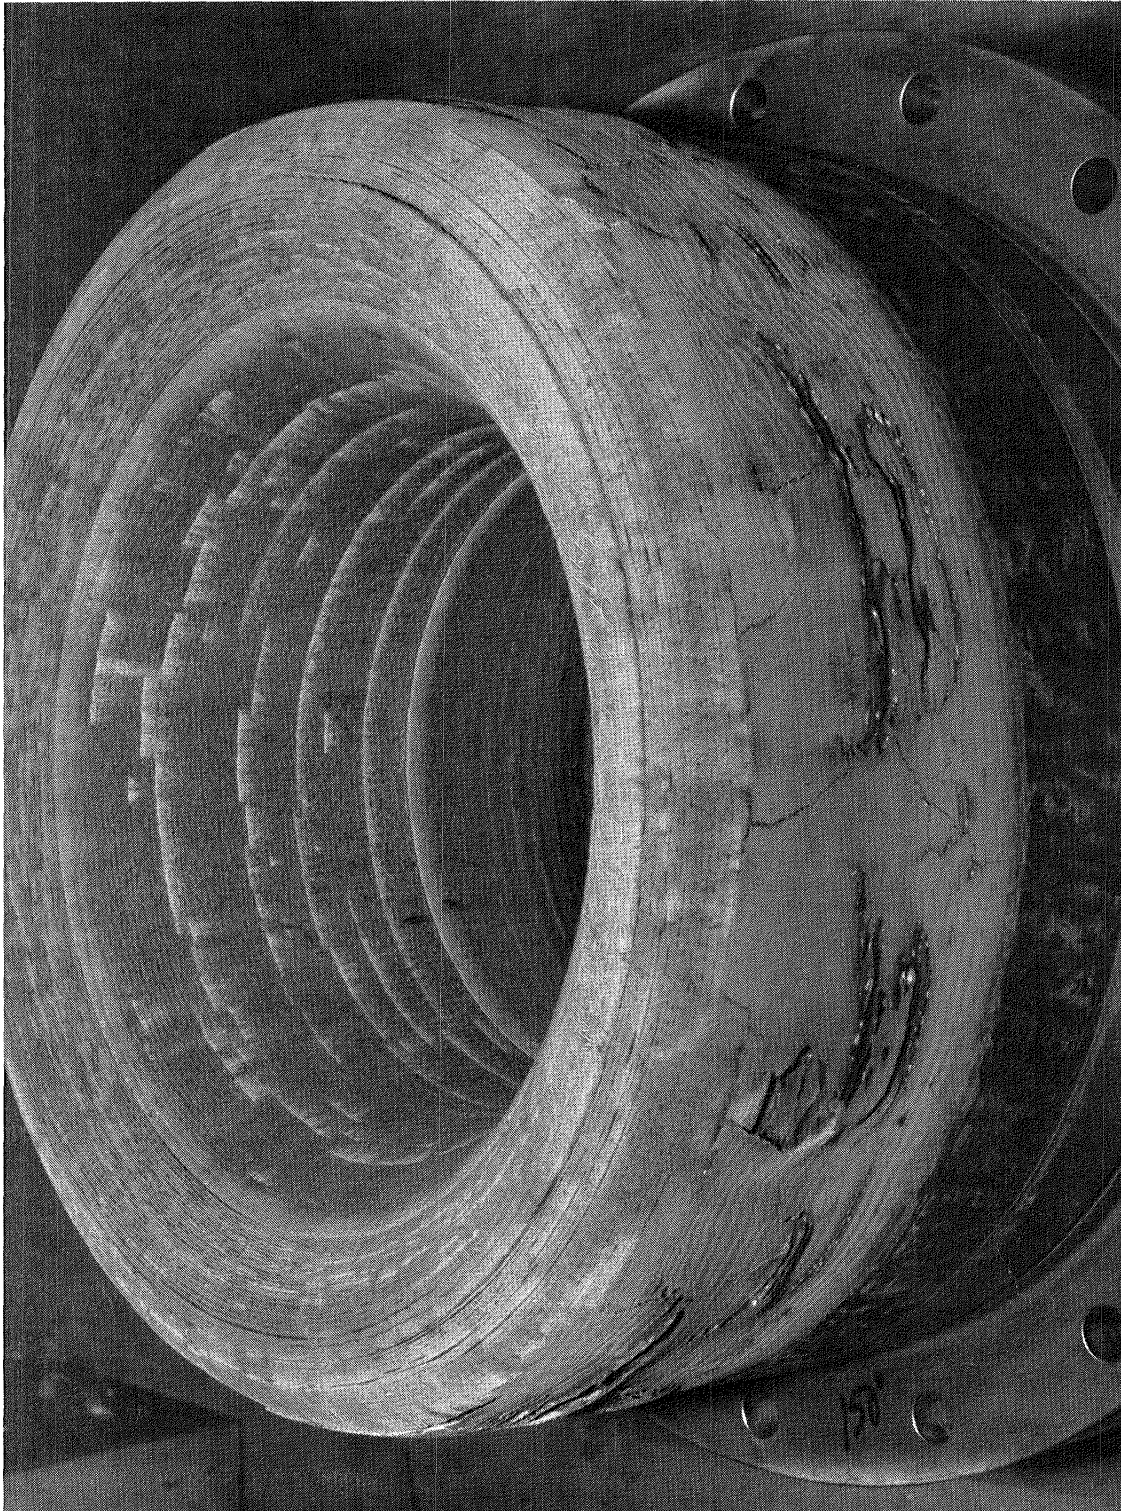
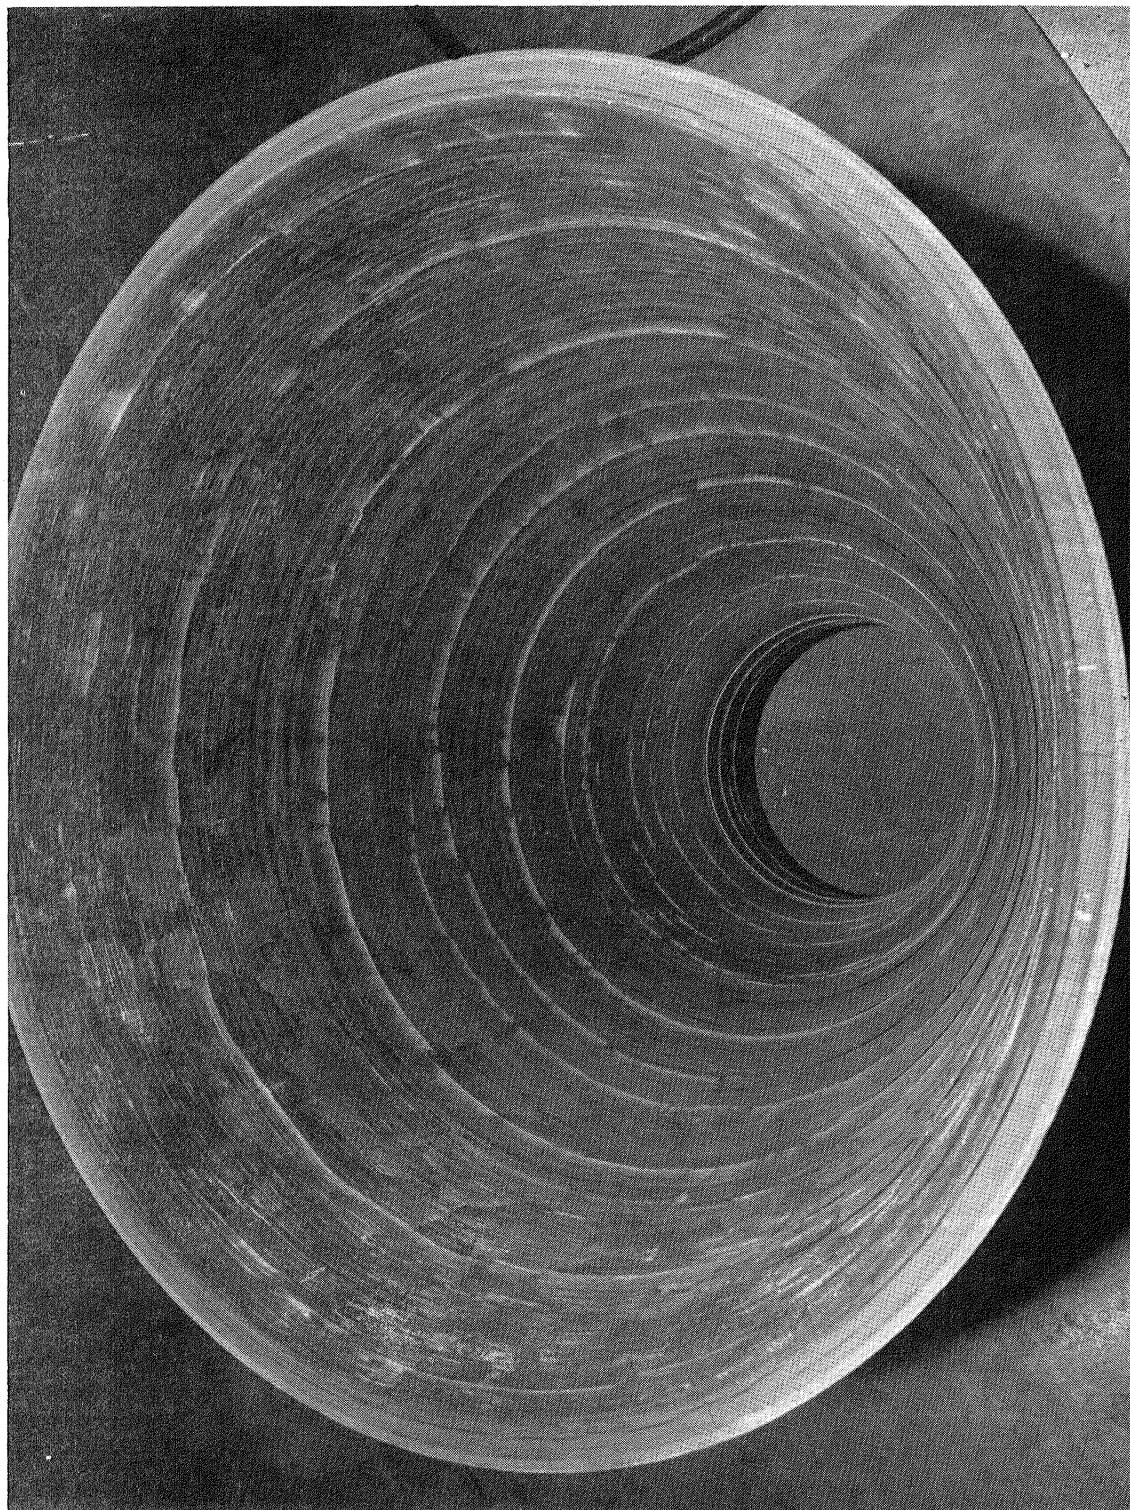
Overall condition of the N-1 nozzle after testing was good. Erosion at the nose, through the throat and aft exit cone was quite smooth, uniform, and symmetrical. Typical separations and delaminations, due to heat soak, quench, and cooldown were noted in the carbon phenolic materials, particularly in the OD shell insulator and the aft section of the exit cone where material ply orientation is parallel to centerline. The condition of the nozzle is graphically shown in Figures 7, 8, and 9.

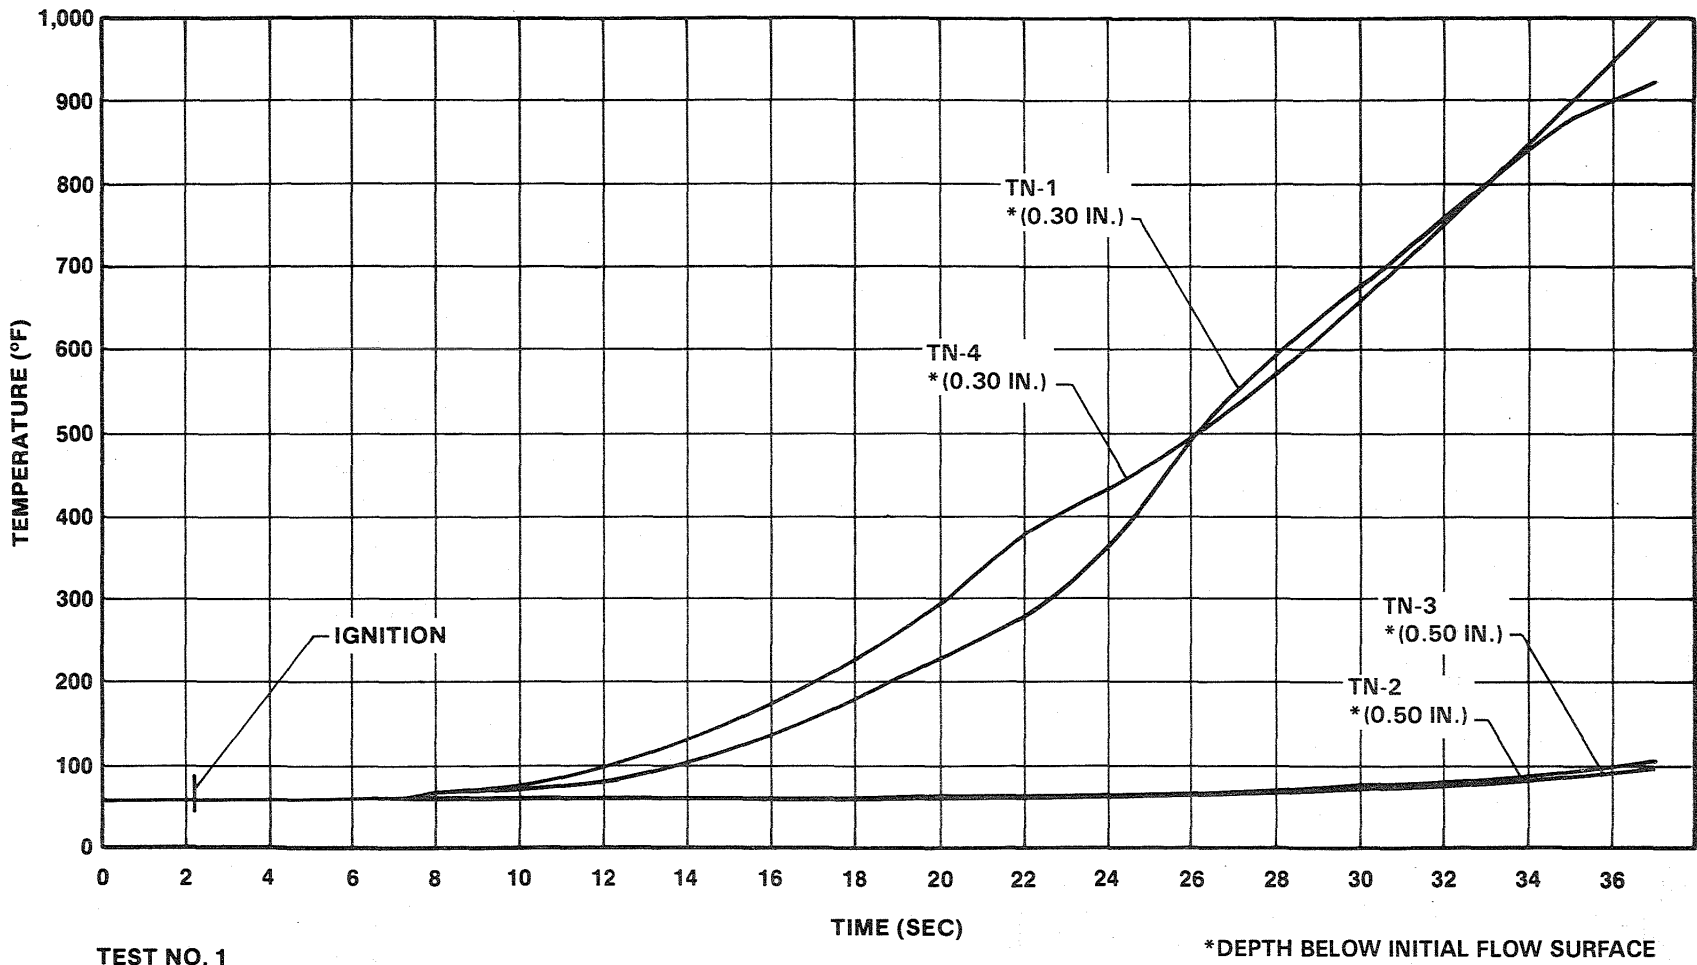
Figure 23. N-1 Nozzle Temperature Versus Time

Just prior to test, all thermocouples read 60°F. The initial temperature rise for the shallower thermocouples, TN-1 and TN-4, occurred at T + 7.4 sec and continued to rise throughout the test. Temperatures of 1,000°F (TN-4) and 920°F (TN-1) were recorded at 37.00 sec. TN-2 and TN-3, the deeper thermocouples, showed a gradual temperature rise over motor burn time. TN-3 recorded a temperature of 110°F at 37 sec and TN-2 recorded a temperature of 100°F.

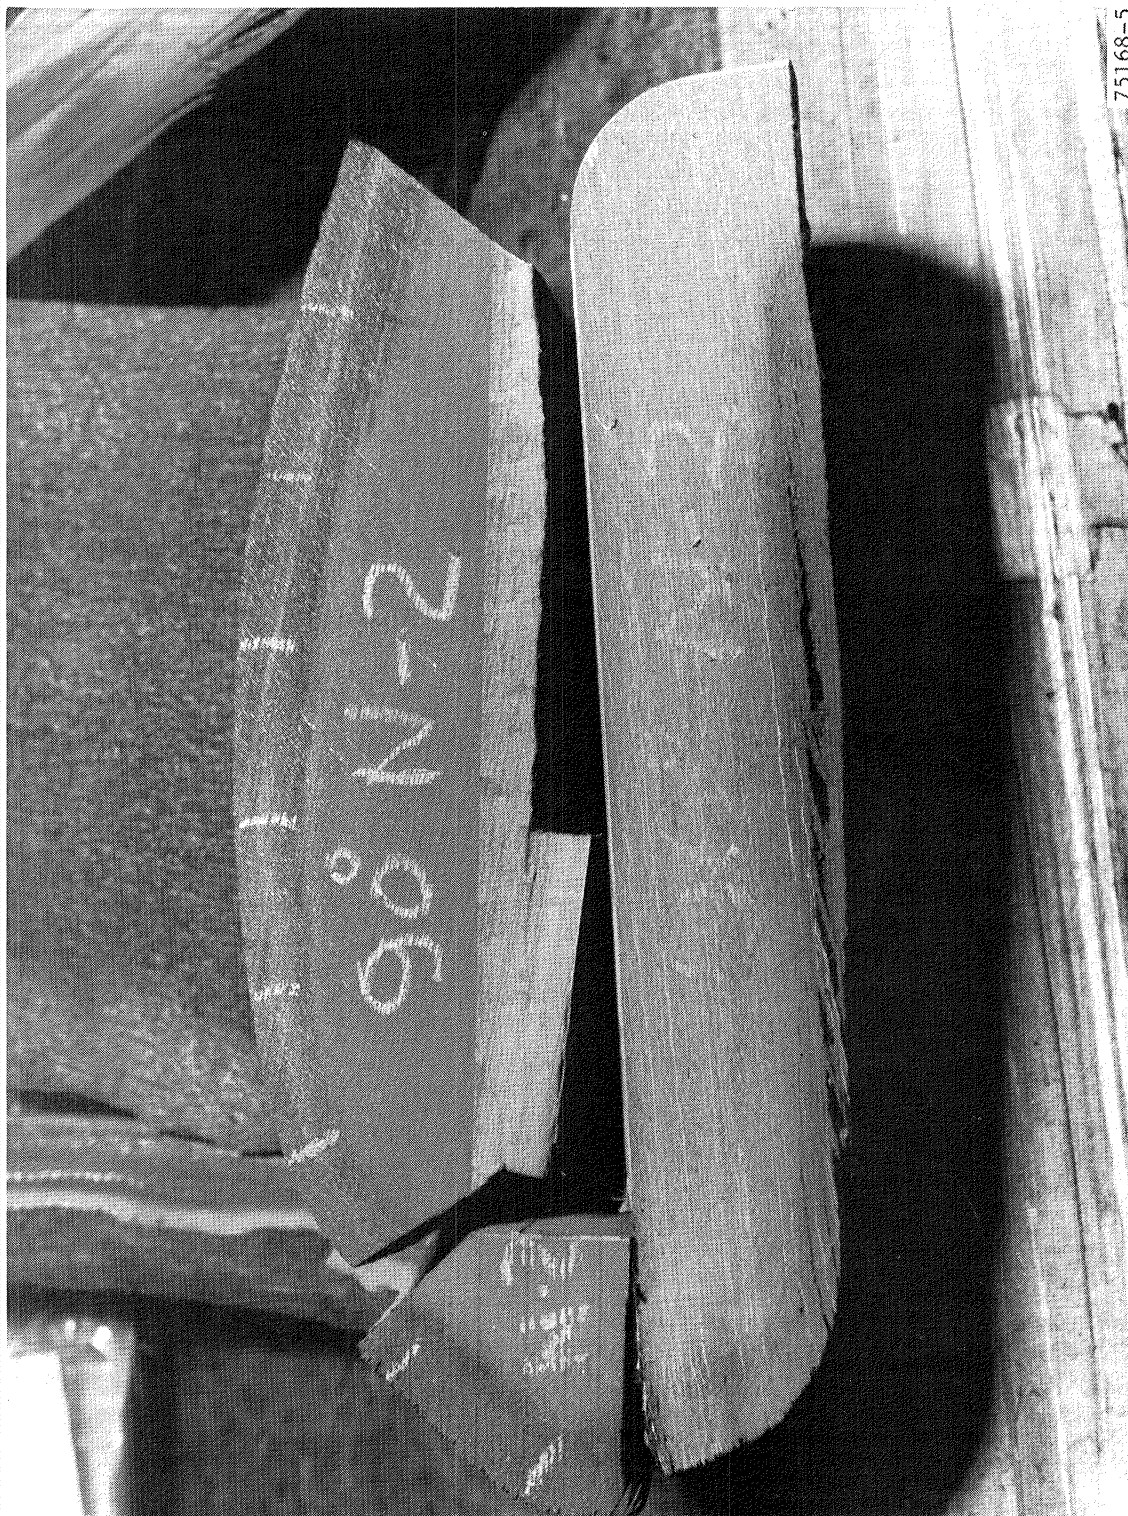
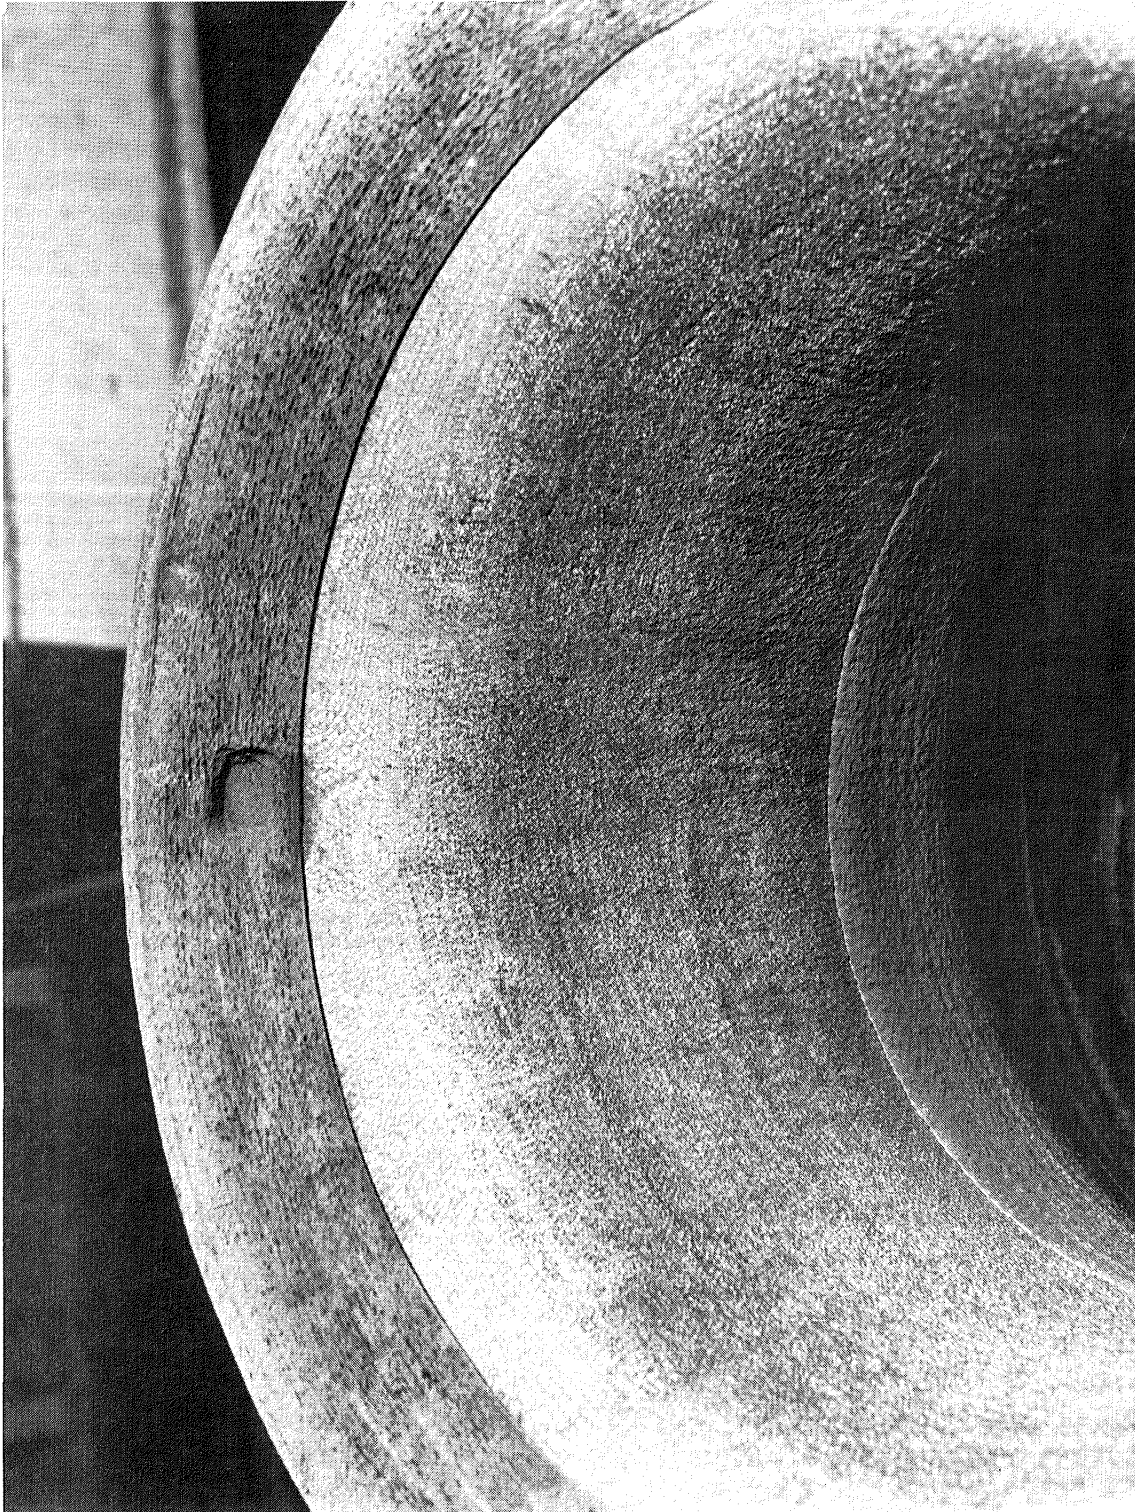
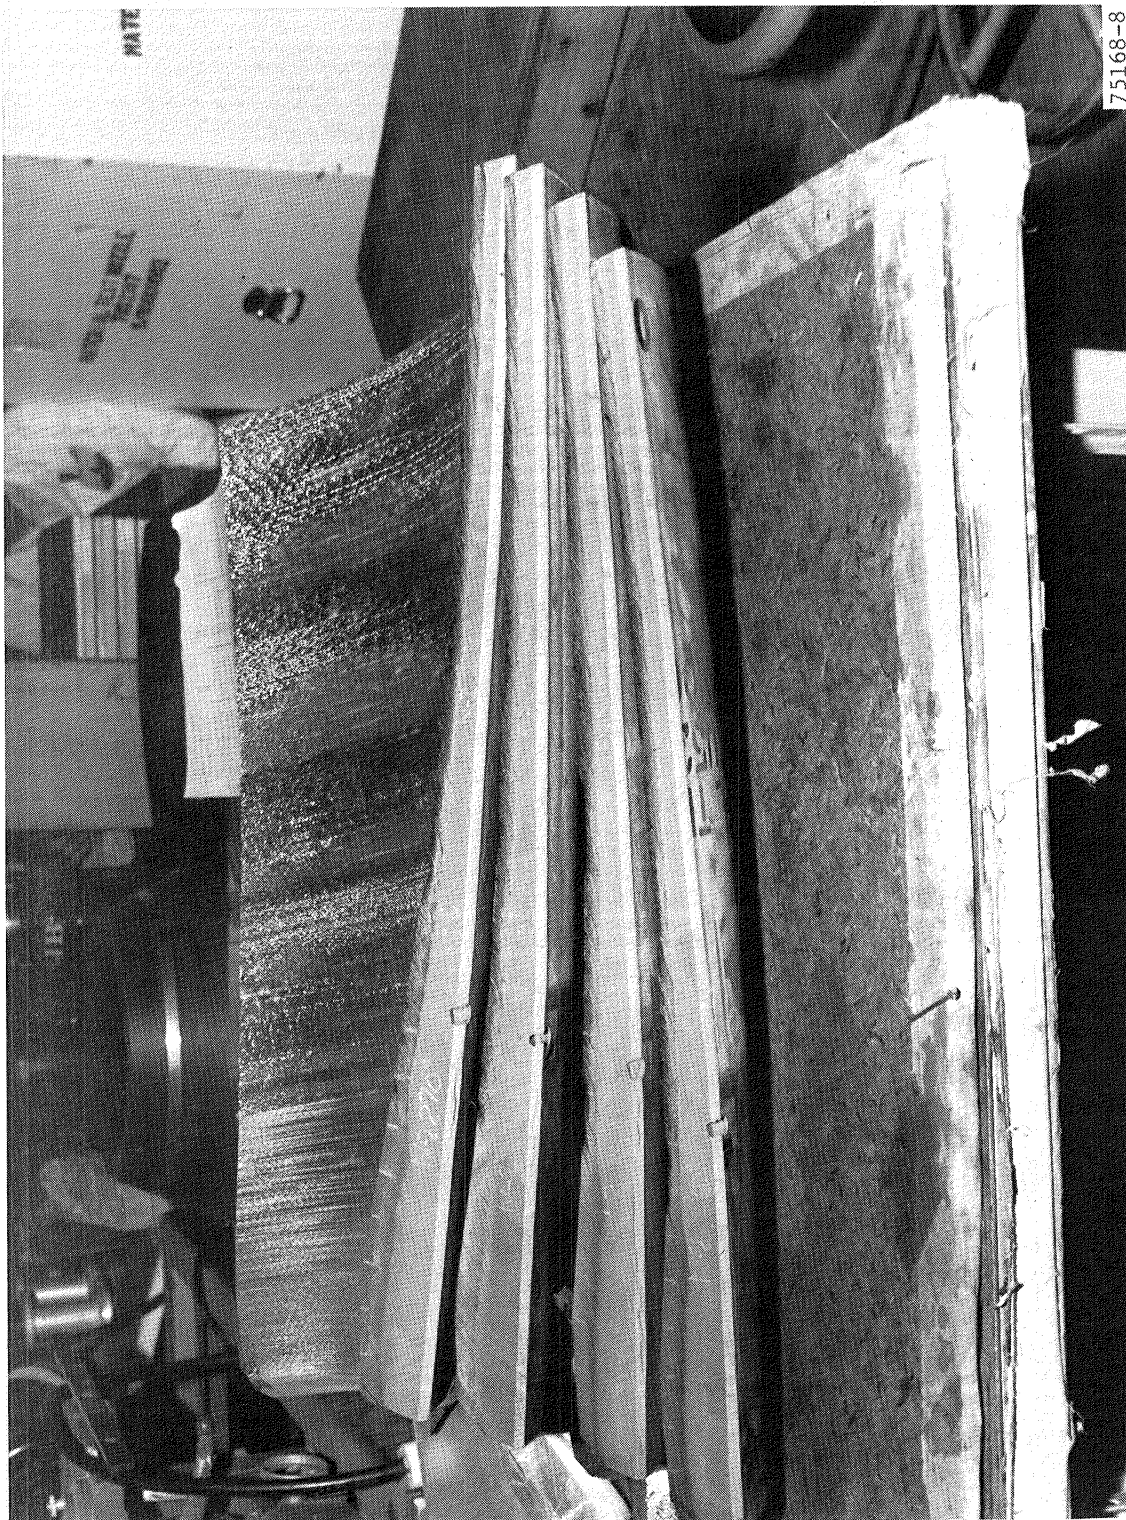
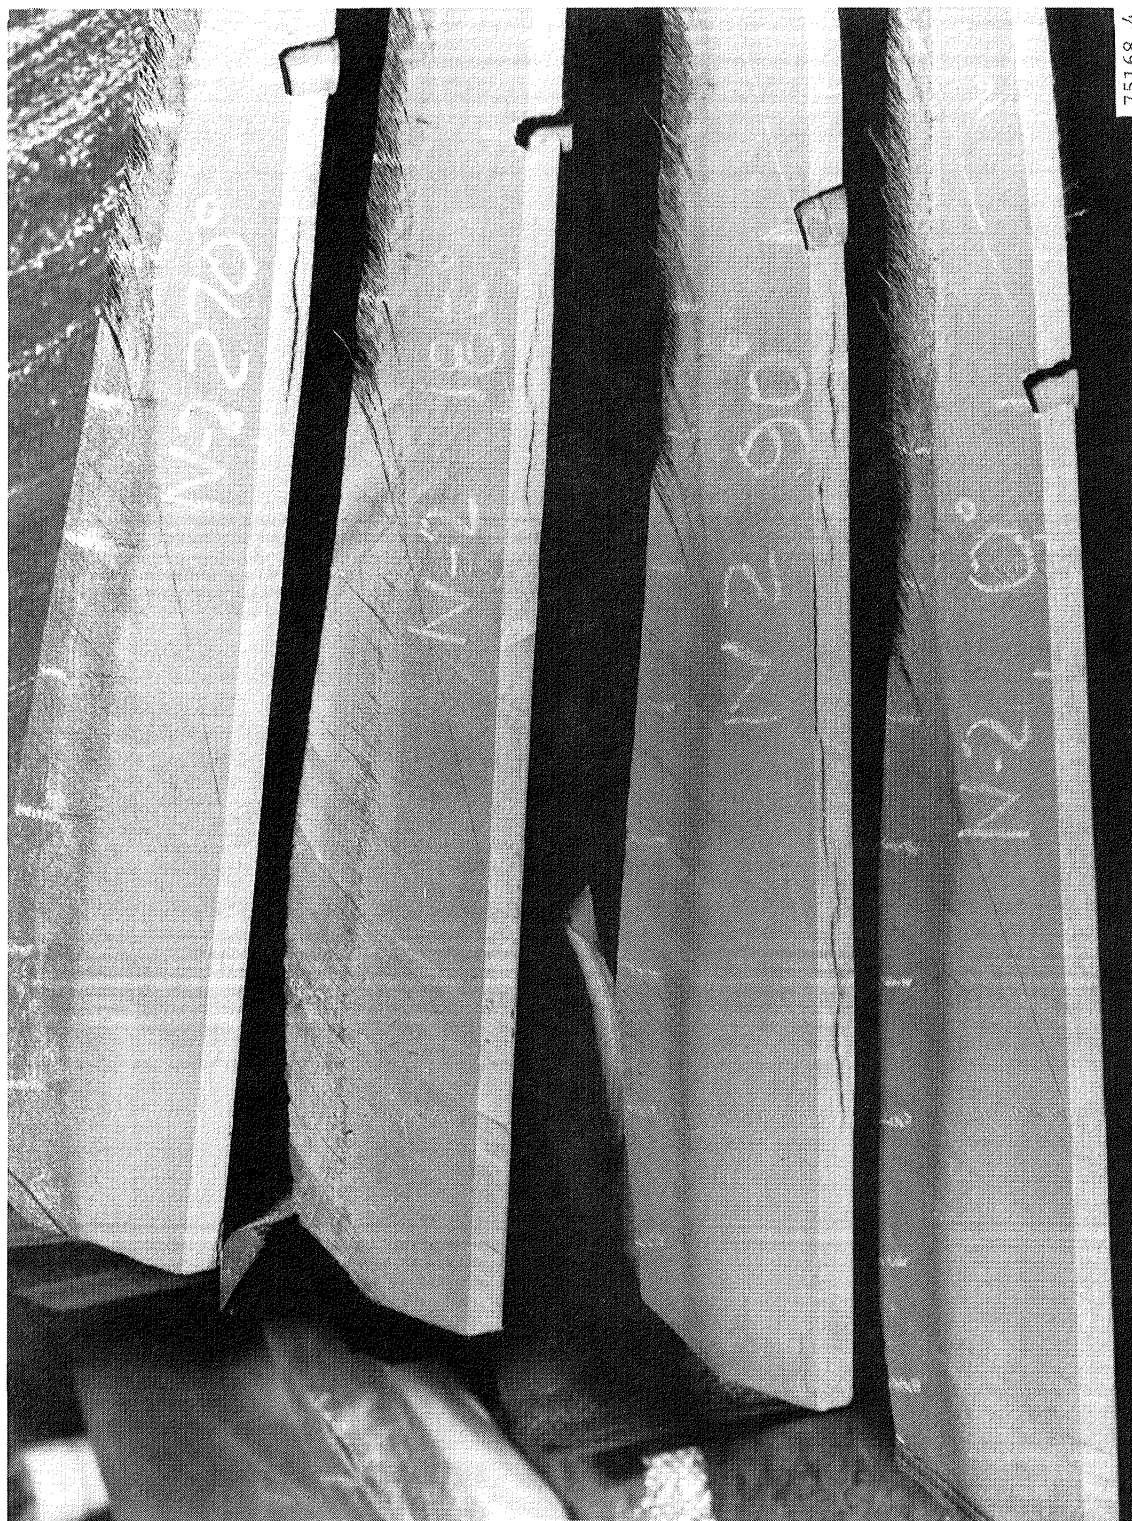
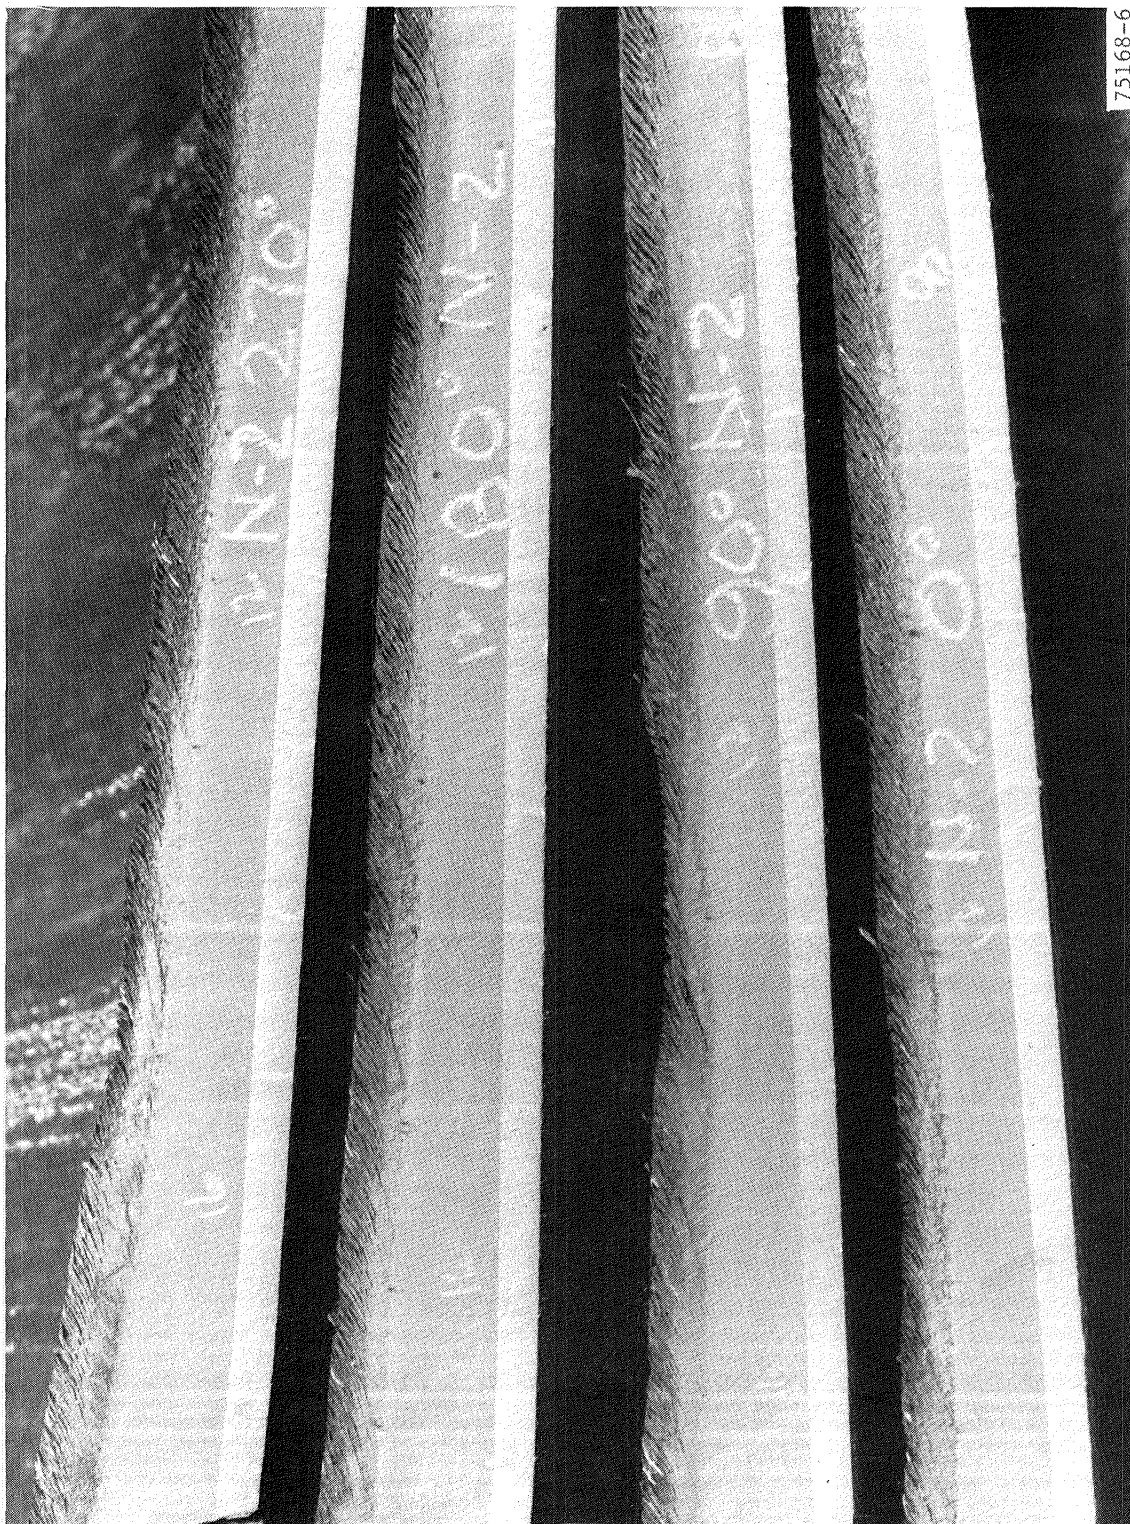
The nozzle was in generally good condition but showed more apparent separation, swelling, and curl up of the material in the aft, parallel to centerline, wrap in the cone aft section and shell insulator.

The aft cone charred, separated, and curled up material was quite soft and low in strength and showed several circumferential bands where apparent spalling had occurred. The ceramic mat throat insulator was not heat affected (charred); but, during metal shell refurbishment, it fractured across the plies near the center of the part, indicating low strength of the material.

The metal housing showed no indication of damage but was somewhat discolored by heating for plastic parts removal. The post-test condition of the plastics is shown in Figures 7 through 11.

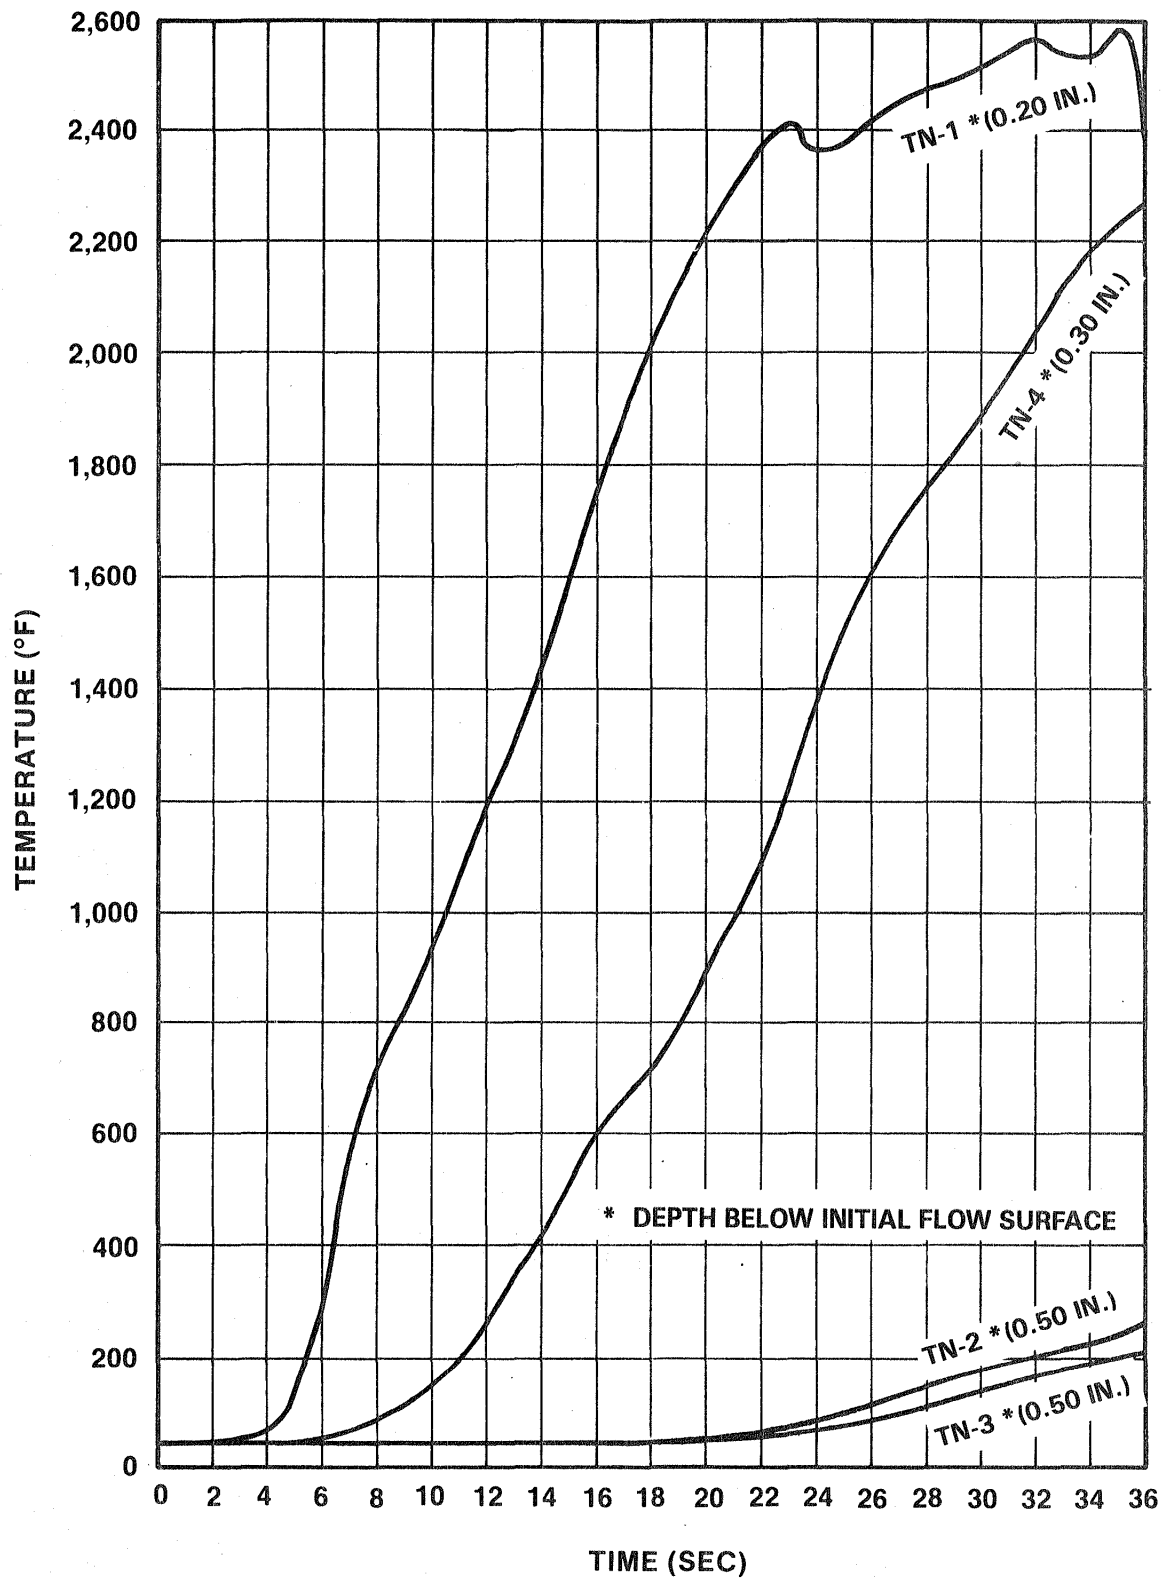
Figure 16. N-2 Nozzle Thermocouple Data

Just prior to testing, all thermocouples read 40°F. The initial temperature rise for the shallower thermocouples, TN-1 and TN-4, occurred at  $T + 4$  and  $T + 6$  sec and continued to rise throughout the test. Temperatures of 2,590°F (TN-1) and 2,270°F (TN-4) were recorded at 36 sec. TN-2 and TN-3, the deeper thermocouples, showed a gradual temperature rise over motor burn time. TN-3 recorded a temperature of 205°F at 36 sec, and TN-2 recorded a temperature of 260°F.

The peak temperatures of TN-1 and TN-4 indicate these instruments were within the char depth of the material; char formation in phenolic is generally defined as occurring within a temperature band of 800° to 1,000°F. TN-2 and TN-3 were experiencing heating but were still below the charred region of the material.

A comparison of the thermocouple data from the baseline rayon material and the PAN materials tested in the N-2 nozzle shows the PAN materials to be much hotter. At 0.3 in. from the surface the baseline temperature was 900 to 1,000°F compared to 2,270°F for the PAN material. At a 0.5 in. depth the comparison is 100°F for the baseline and 200° to 260°F for the PAN material.
